LITTLE RIVER UPPER DAM
ME 00289

PHASE I INSPECTION REPORT
NATIONAL DAM INSPECTION PROGRAM

NOVEMBER 1979

Identification No.: ME00289
Name of Dam: Little River Upper Dam
Town: Belfast
County and State: Waldo, Maine
Stream: Little River
Date of Inspection: September 17, 1979

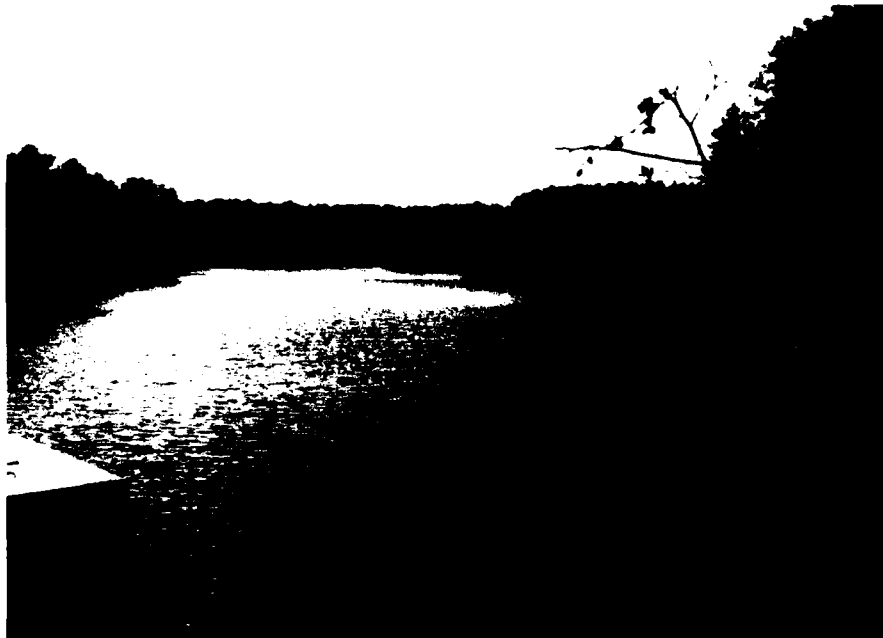
d. Reservoir Area. The watershed above the reservoir is rolling and partially wooded. (See Appendix C - Figure 12.) No structures were observed on the shore of the reservoir. No evidence of significant sedimentation in the reservoir was observed.

September 17, 1979
Figure 12 - Looking upstream at the reservoir from the
top of the north abutment.

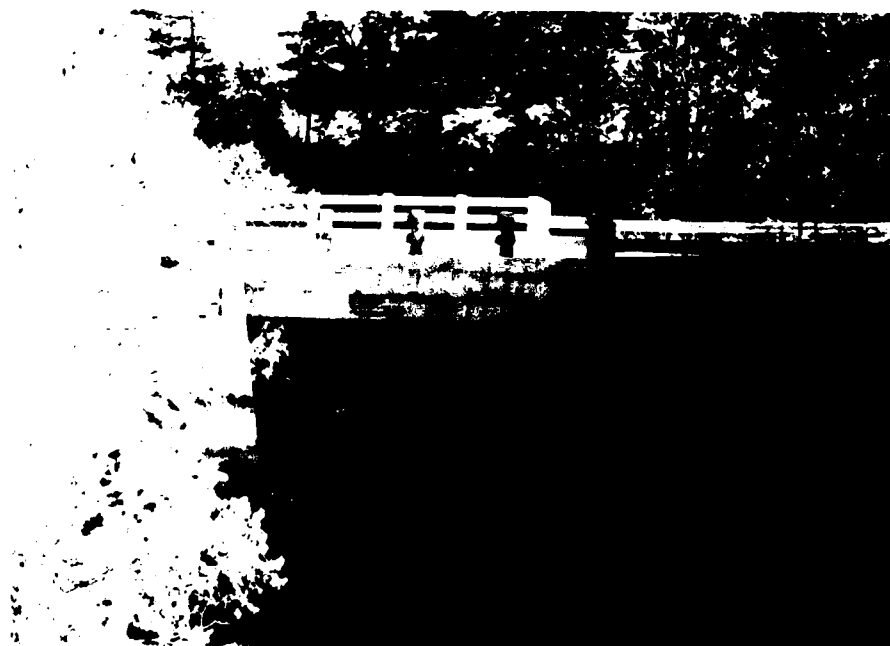
September 17, 1979
Figure 13 - Herrick Road Bridge 200' downstream of
the dam.

CONCLUSIONS: A BREACH OF LITTLE RIVER UPPER
DAM COULD CAUSE OVERTOPPING AND POSSIBLE DAMAGE
TO THE HERRICK ROAD BRIDGE AND COULD ALSO CAUSE
OVERTOPPING OF LOWER RESERVOIR DAM.
THE BREACH COULD ALSO CAUSE LOSS OF A REGU-
-LATING RESERVOIR FOR USE IN WATER SUPPLY AND
THEREFORE POSES A HAZARD TO A PUBLIC UTILITY.
THERE WOULD PROBABLY BE NO LOSS OF LIFE BUT IT COULD
CAUSE APPRECIABLE PROPERTY DAMAGE. THEREFORE,
LITTLE RIVER UPPER DAM HAS BEEN CLASSIFIED AS
SIGNIFICANT HAZARD
